Bentley and Associates LLC.
7400 Hwy 11E
Lenoir City, TN 37772
8659862516
Inspect Donnie Bentley TN Lic#183

Home Inspection

Happy Home owner
Anytown
Our city TN
Todays date

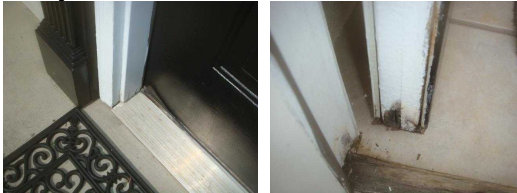
7. Marginal Entry Doors: Metal entry door **Water damage on front door and trim**

4. Entry Doors: Metal entry door **Water damage on front door and trim**

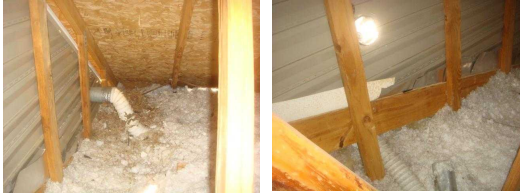
1. Method of Inspection: In the attic
2. Acceptable Roof Framing: 2x4 Truss
3. Acceptable Sheathing: OSB
4. Defective Ventilation: Roof and soffit vents **Damaged vents inside attic, birds nesting, recommend repairs**

6. Main Attic Ventilation: Roof and soffit vents Damaged vents inside attic, birds nesting, recommend repairs

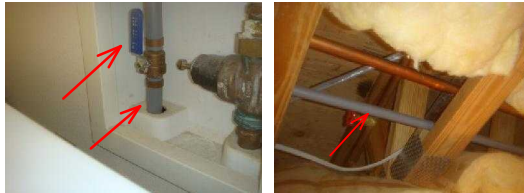
- 1. Defective Service Line: Polybutelene There is one section of polybutelene pipe in the basement that goes up to laundry room water cut off, Polybutelene line present as main service line in basement, Unable to see all underground piping the line coming through the foundation is copper. No leakage visible at the time of inspection. Recommend evaluation by a licensed plumbing contractor. Polybutelene plumbing is subject to failures, Recommend replacing polybutelene pipes

9. Service Line: Polybutelene There is one section of polybutelene pipe in the basement that goes up to laundry room water cut off, Polybutelene line present as main service line in basement, Unable to see all underground piping the line coming through the foundation is copper. No leakage visible at the time of inspection. Recommend evaluation by a licensed plumbing contractor. Polybutelene plumbing is subject to failures, Recommend replacing polybutelene pipes

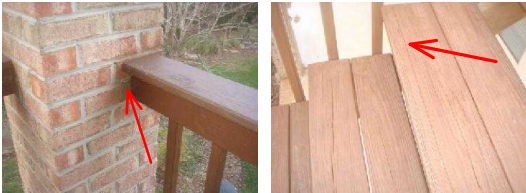
3. Acceptable Patio: Concrete Cracks present
4. Defective Deck: Treated wood Right rail bracket is loose, Recommended securing, 3rd step down from top has broken tread, Recommend repair

1. Deck: Treated wood Right rail bracket is loose, Recommended securing, 3rd step down from top has broken tread, Recommend repair

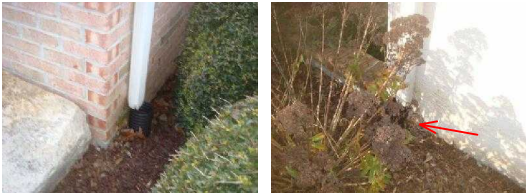
Leader/Extension: Plastic and splash blocks **Extensions are pulling away in front and rear, Recommend repair**

4. Leader/Extension: Plastic and splash blocks Extensions are pulling away in front and rear, Recommend repair
