Bentley and Associates, LLC
7400 Hwy 11E
Lenoir City, TN 37772
865-986-2516
Donnie Bentley TN Lic# 183

Home Inspection

Happy Home Buyer
125 Happy Lane
Anytown TN 37772
The date of the inspection

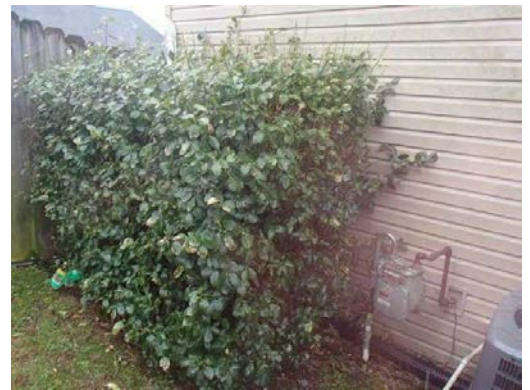
- 8. Acceptable Exterior Surface Drain: Surface drain
- 9. Acceptable Swale: Adequate slope and depth for drainage
- 10. Acceptable Vegetation: Shrubs - [Recommend trimming shrubs](#)

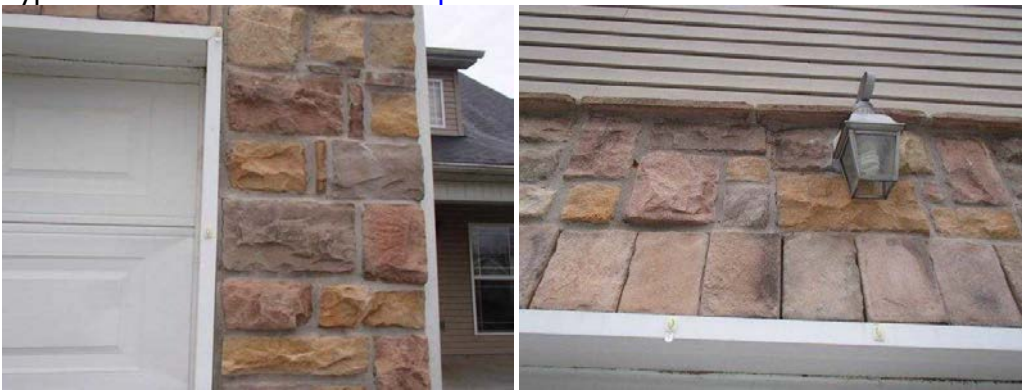
1. Views of Exterior
2. Acceptable Type: Faux Stone - **Small cracks present**

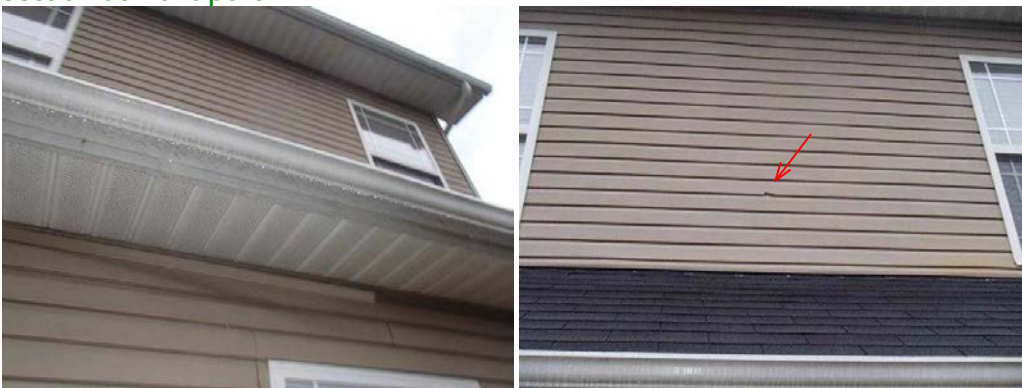
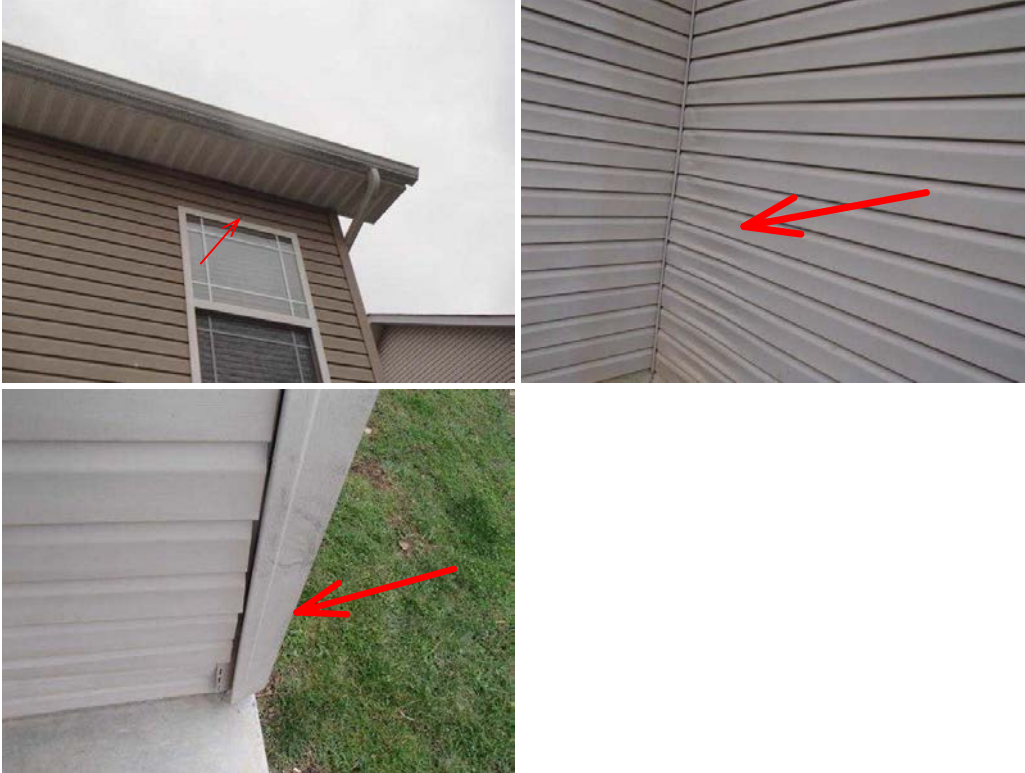
3. Views of Exterior
4. Marginal Type: Vinyl siding - **Small holes and cracks in rear, Sagging from heat in rear corner, Loose section at front porch**

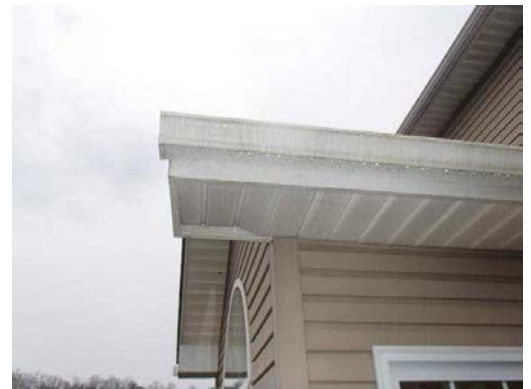
- 5. Not Present Trim: Wood, Aluminum and vinyl
- 6. Views of Exterior
- 7. Acceptable Fascia: Aluminum clad
- 8. Marginal Soffits: Vinyl - **Small section loose in rear**

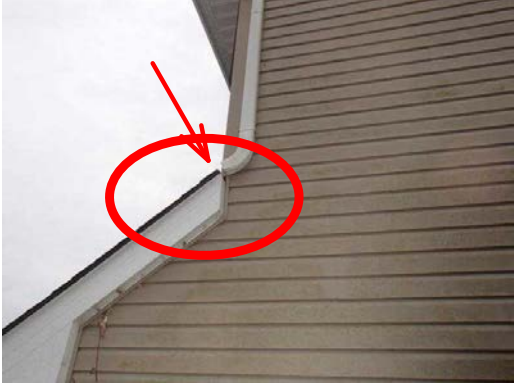
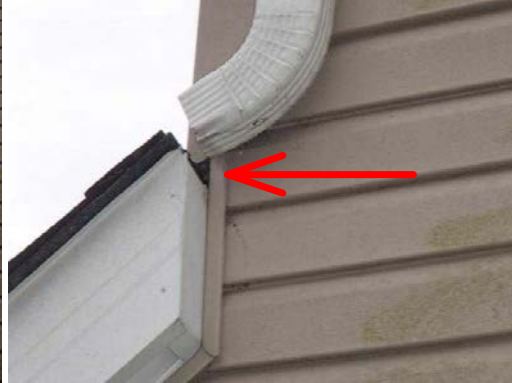
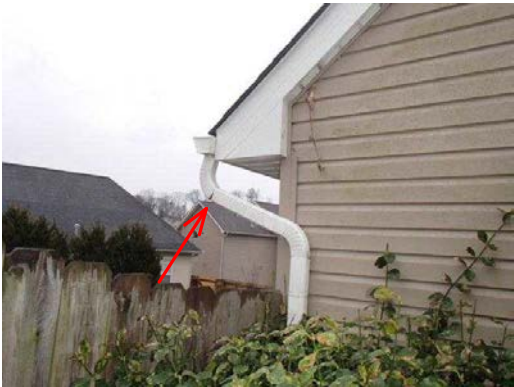
Downspouts: (continued)

11. Defective Downspouts: Aluminum - **Rear left side downspout is turning water into opening above soffit recommend repair and have a contractor evaluate to see if there is water damage inside wall and repair downspout**

Pulled loose in rear, Recommend repair

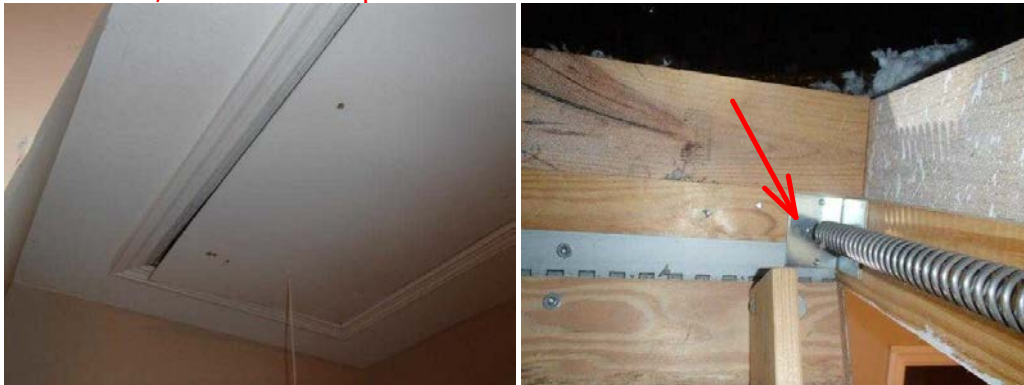
3. Defective Access Pull down - **Recommend adding nails to hole provided in the metal bracket at top**
Cover loose, recommend repair

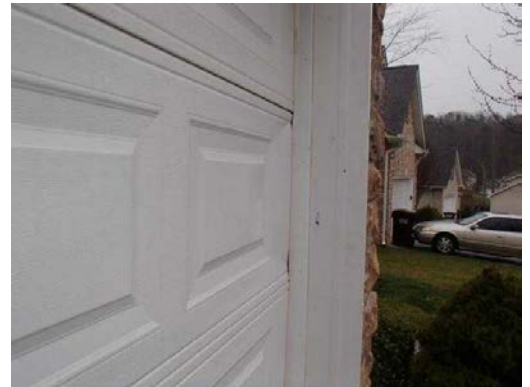
2. Type of Structure: Attached Car Spaces: 2
3. Acceptable Garage Doors: Metal - **Dents present**

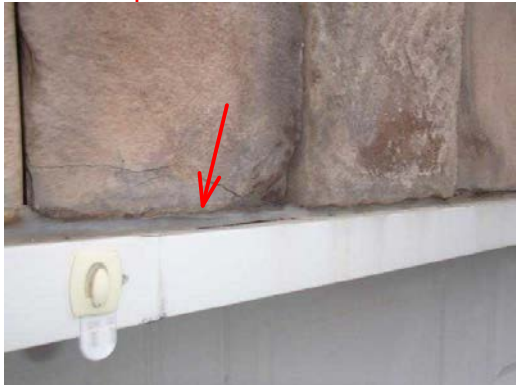
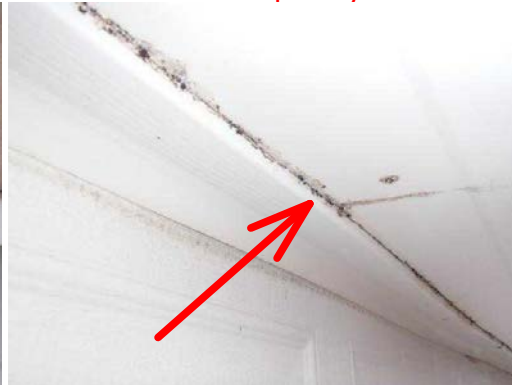
4. Defective

Garage door trim Aluminum clad - Evidence of past water intrusion, Caulk added, Soft area on overhead piece of wood trim. Recommend evaluation and repair by a licensed contractor

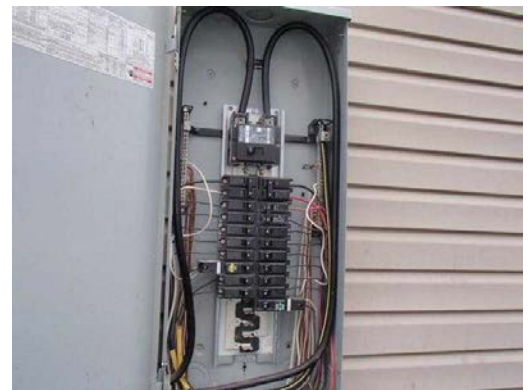
1. Service Size Amps: 200 Volts: 110-240 VAC
 2. Acceptable Service: Aluminum
 3. Acceptable 120 VAC Branch Circuits: Copper
 4. Acceptable 240 VAC Branch Circuits: Copper
 5. Acceptable Smoke Detectors: Present - [Recommend installing batteries](#)
 6. Acceptable Conductor Type: Non-metallic sheathed cable
 7. Acceptable Ground: Visible wire going into ground
- Outside Electric Panel
8. Acceptable Manufacturer: Cutler-Hammer

9. Acceptable Panel Cover Present, Good Condition
10. Maximum Capacity: 200 Amps
11. Acceptable Main Breaker Size: 200 Amps
12. Acceptable Breakers: Copper
13. Is the panel bonded? Yes
14. FYI All electrical repairs and updates should be performed by a licensed electrician.

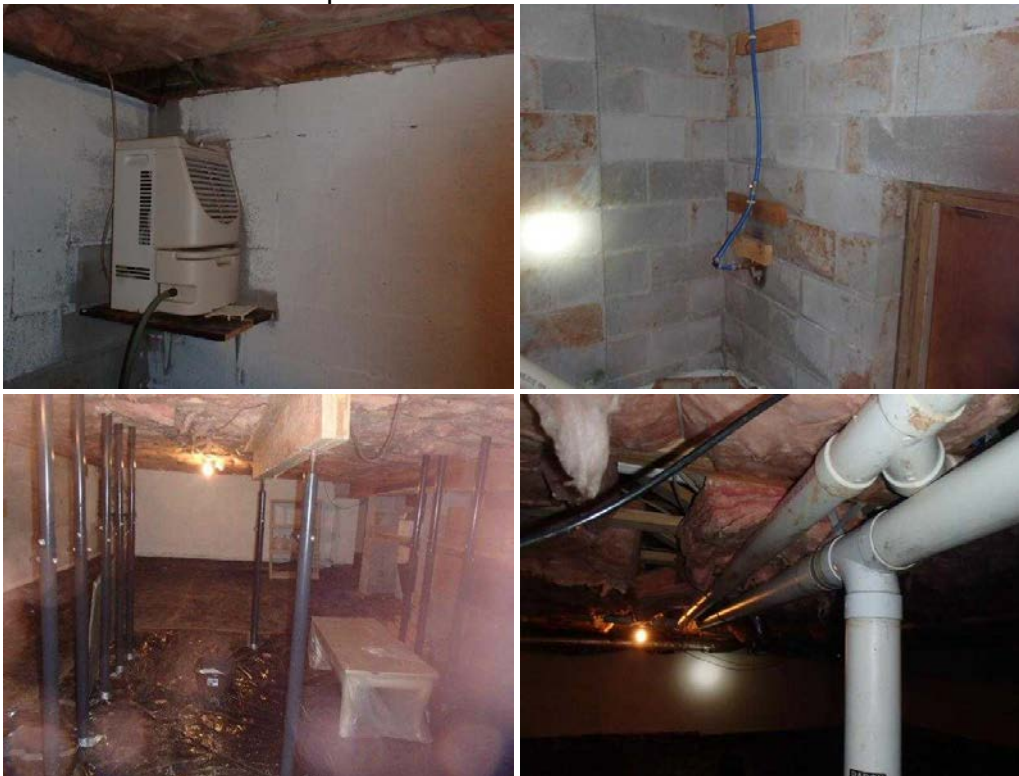
1. View from inside Crawl Space

3. Acceptable Access: Door
4. Acceptable Moisture Intrusion: No moisture present at time of inspection
5. Acceptable Moisture Location: No moisture present at time of inspection
6. Acceptable Moisture Barrier: No moisture barrier present
7. Acceptable Insulation: Fiberglass
8. Acceptable Vapor Barrier: Paper
9. Acceptable Ventilation: Vents
10. Acceptable Electrical: 110 VAC
11. Crawlspace should be inspected periodically by a qualified Pest Control Company for termites, pests and rodents.

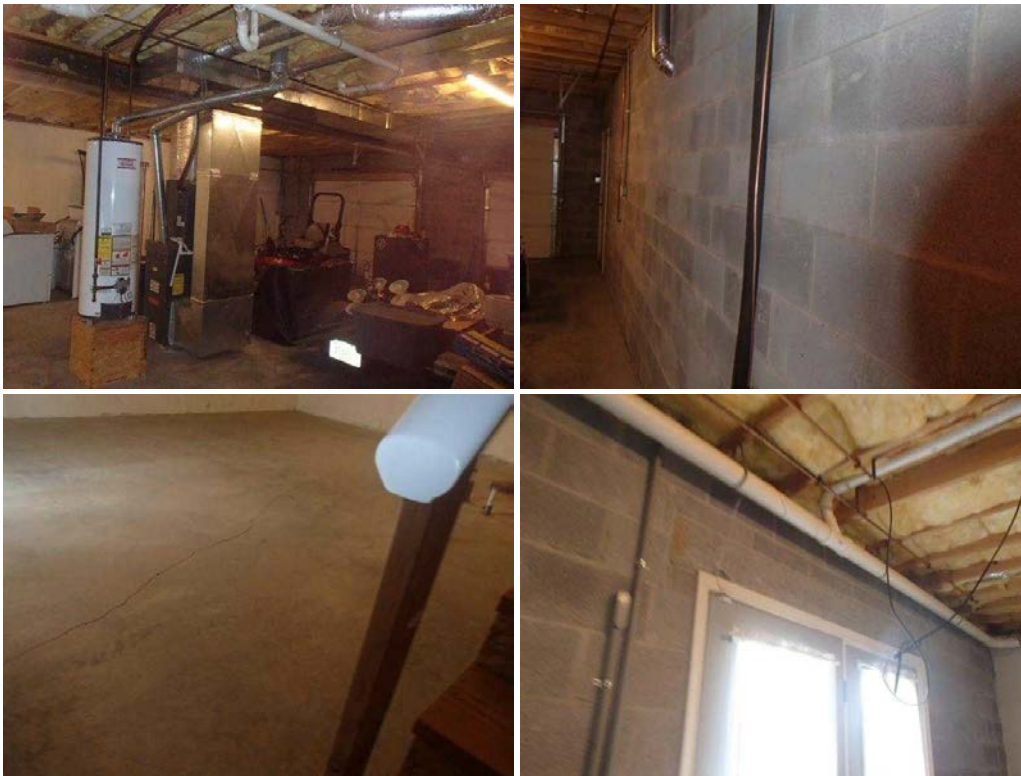
1. Views of basement

- 2. Acceptable Ceiling: Exposed framing
- 3. Acceptable Walls: Block
- 4. Acceptable Floor: Concrete - Cracks present
- 5. Acceptable Electrical: 110 VAC GFCI
- 6. Acceptable Basement Stairs/Railings: Present
- 7. Acceptable Insulation: Fiberglass
- 8. Acceptable Moisture Intrusion: Dry at the time of the inspection
- 9. Acceptable Smoke Detector: Present

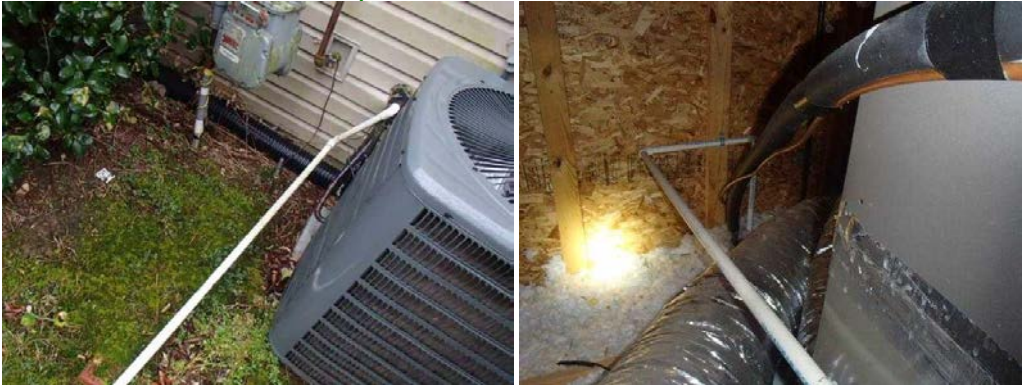
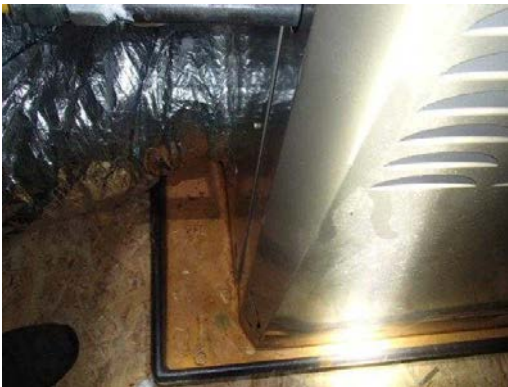
1. Acceptable A/C System Operation: Functional - **To avoid possible compressor damage due to outside temperature below 60 degrees, the unit was not tested.**
2. Marginal Condensate Removal: PVC - **There is evidence of past overflow in the drain pan inside the attic. There is no safety overflow switch present. Recommend installing a safety switch and having a HVAC contractor evaluate system**

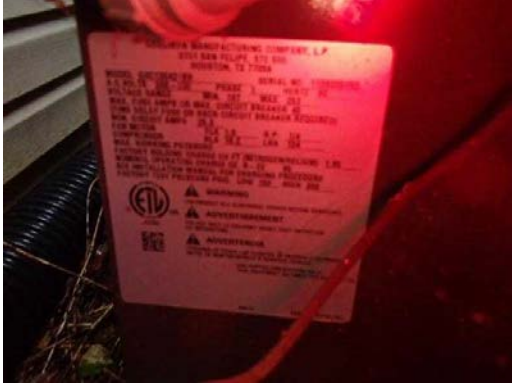
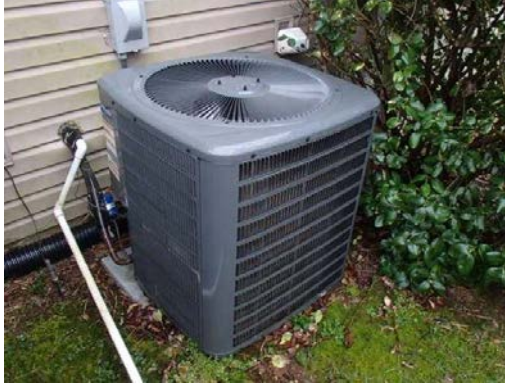
4. Manufacturer: Goodman

5. Area Served: Whole building Approximate Age: 4 Years

6. Fuel Type: Electric Temperature Differential: na

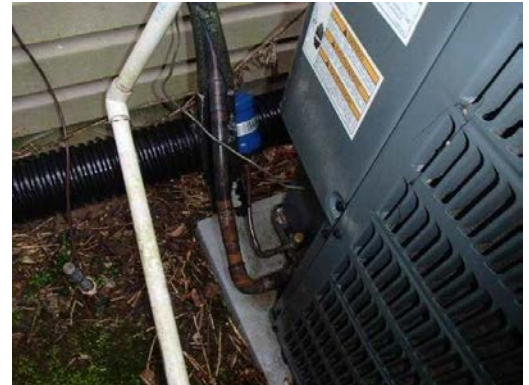
9. Marginal Refrigerant Lines: Copper - **Missing insulation on refrigerant line, Recommend adding insulation to line**

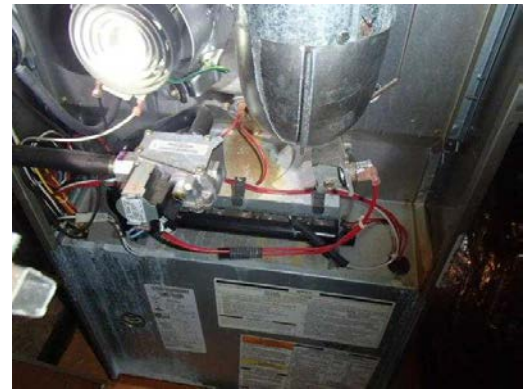
1. Acceptable Heating System Operation: Adequate
2. Manufacturer: Carrier

3. Type: Forced air Capacity: Adequate for home
4. Area Served: Whole building Approximate Age: 10 Years
5. Fuel Type: Natural gas
6. Acceptable Heat Exchanger: 4 Burner
7. Unable to Inspect: 90%
8. Acceptable Thermostats: Individual
9. Acceptable Blower Fan/Filter: Direct drive with disposable filter
10. Acceptable Distribution: Metal and flexible duct
11. Acceptable Flue Pipe: Double wall
12. FYI For system longevity and efficiency, filters be changed every 30 days or according to manufacturers recommendations, and the system be inspected and serviced annually by a qualified HVAC technician.

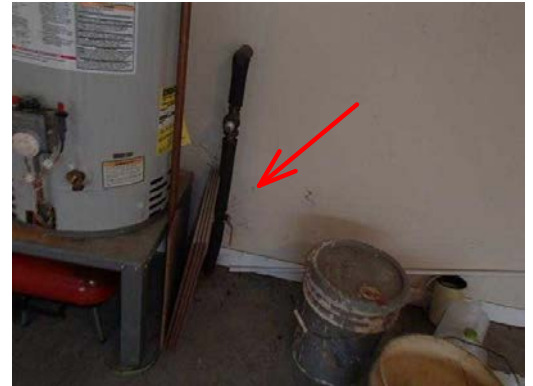
1. Acceptable Service Line: Copper

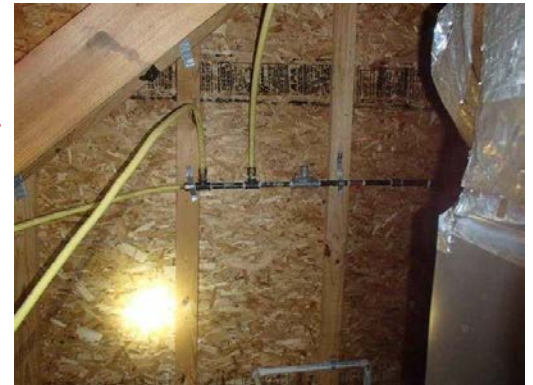
6. Defective Gas Service Lines: Cast iron, CSST - **Yellow Corrugated Stainless Steel Tubing (CSST) gas line present and does not appear bonded. Recommend a qualified licensed electrician evaluate and make any necessary repairs. For more information visit www.csstsafety.com**

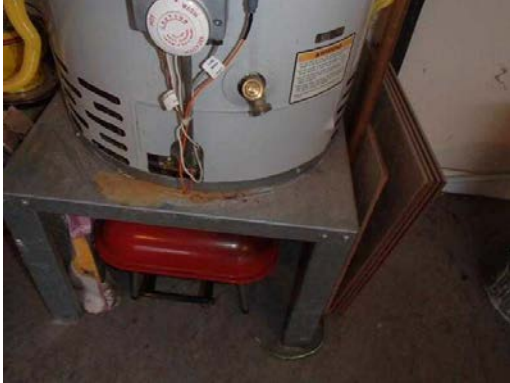
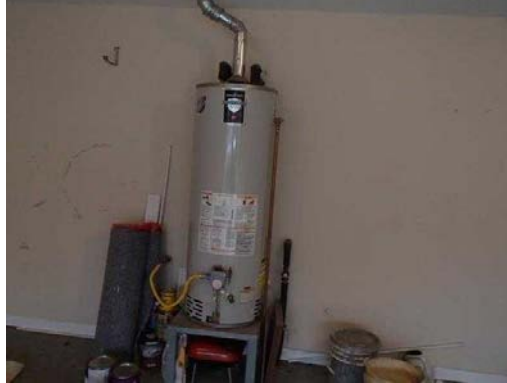
Manufacturer: (continued)

9. Type: Natural gas Capacity: 50 Gal.
10. Approximate Age: 10 Years Area Served: Whole building
11. Acceptable Flue Pipe: Double wall
12. Acceptable TPRV and Drain Tube: Copper
13. FYI Because water can be turned off during real estate sales and transfers, it is recommended that all visible plumbing lines, fixtures and connections be inspected at final walk through, and again periodically for leaks. Follow manufacturers maintenance recommendations for all mechanical devices (water heaters, septic pumps, etc.)

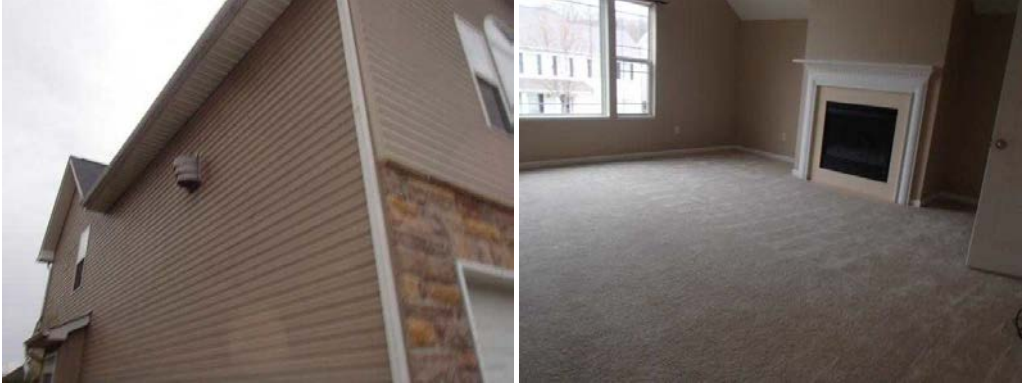
6. Acceptable Flue: Through wall vent

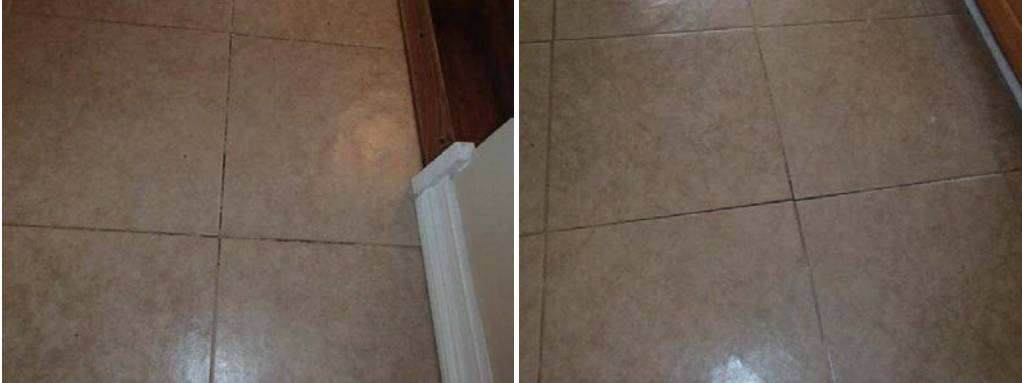
5. Marginal Floor: Tile - Cracks/ loose grout between tiles

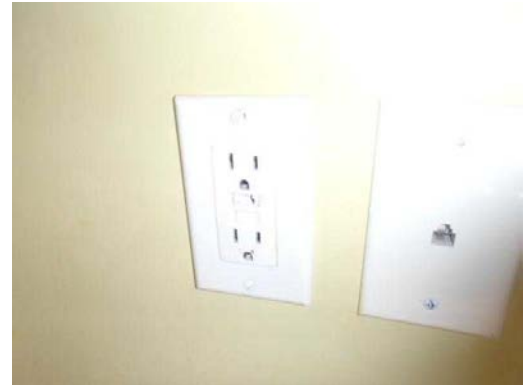
7. Defective

Electrical: 110 VAC GFCI - GFCI Outlet on counter is cracked, Recommend replacement

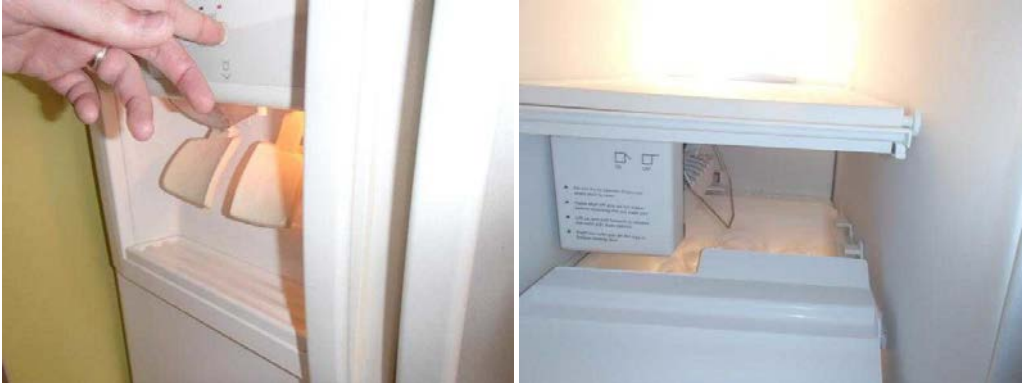
Ventilator: Present
Refrigerator: Whirlpool - Door water dispenser not working

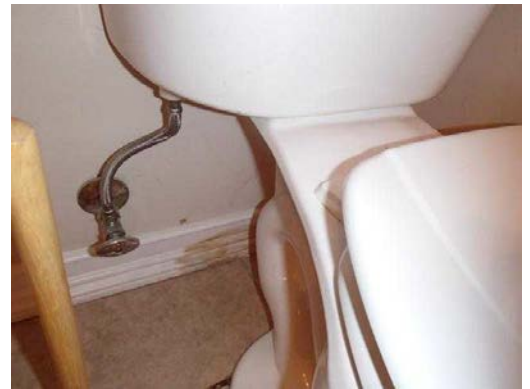
- 2. Acceptable Ceiling: Paint
- 3. Acceptable Walls: Paint - [Water stains present behind toilet](#)

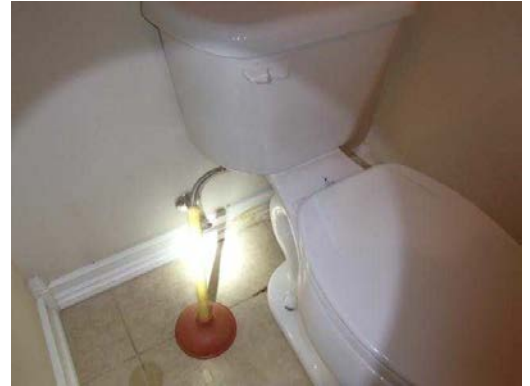
10. Defective Toilets: Adequate - **The toilet is loose at the floor and may require replacement of the wax seal**

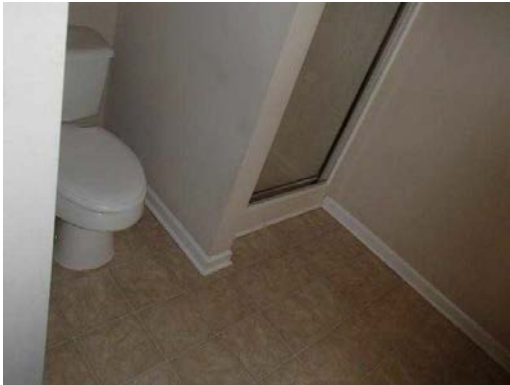
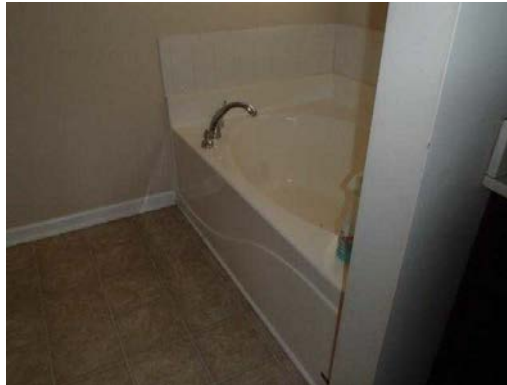
11. View of Bathroom

12. Acceptable Ceiling: Paint
13. Acceptable Walls: Paint
14. Acceptable Floor: Vinyl floor covering
15. Acceptable Doors: Working Properly
16. Acceptable Windows: Good condition
17. Acceptable Electrical: 110 VAC GFCI
18. Acceptable HVAC Source: Present
19. Marginal Ventilation: Present - **Loud operation**

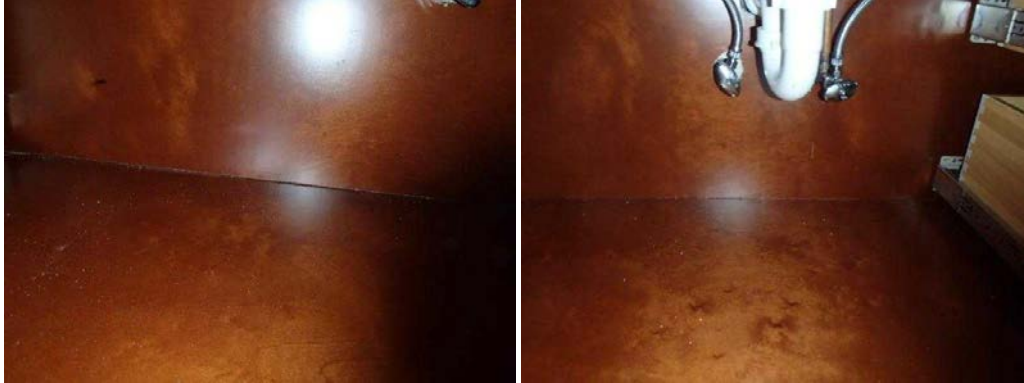
20. Defective

Faucets/Traps: Adequate - **Traps leaking under both sinks**

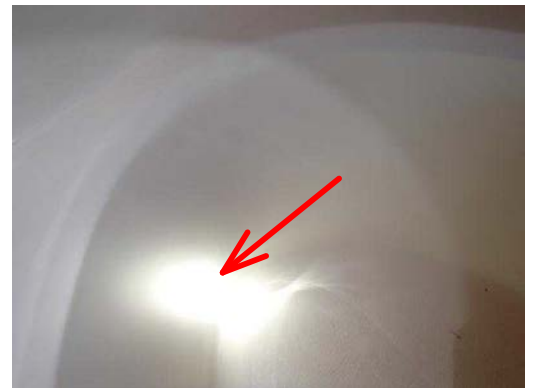
23. Defective

Tub/Surround: Plastic/Fiberglass - **Hole with improper repair, Recommend repairs be made by a professional**

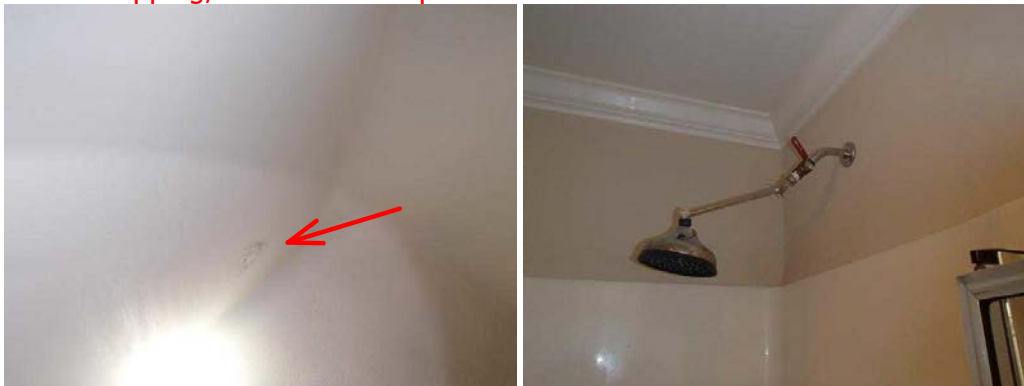
25. Defective

Shower/Surround: Plastic/fiberglass - **Hole with improper repair, Recommend repairs be made by a professional**
Faucet dripping, Recommend repair

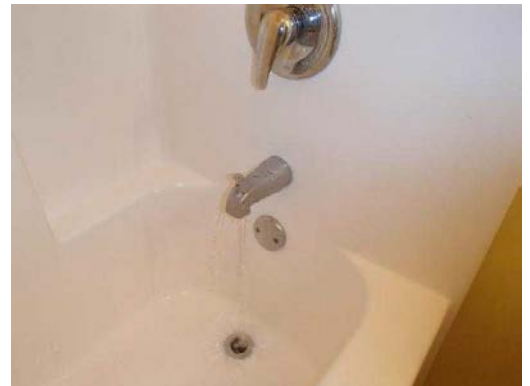
- 27. Acceptable Ceiling: Paint
- 28. Acceptable Walls: Paint
- 29. Acceptable Floor: Vinyl floor covering
- 30. Acceptable Doors: Working Properly
- 31. Acceptable Electrical: 110 VAC GFCI
- 32. Acceptable HVAC Source: Present
- 33. Acceptable Ventilation: Present
- 34. Acceptable Faucets/Traps: Adequate
- 35. Acceptable Sink/Basin: Single bowl
- 36. Acceptable Counter/Cabinet: Adequate
- 37. Defective Tub/Surround: Plastic/Fiberglass - Diverter stuck on shower control

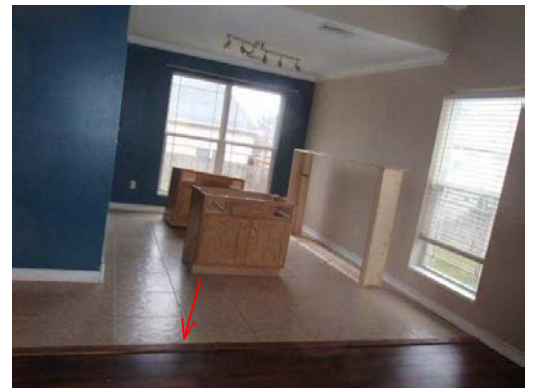
- 2. Acceptable Ceiling: Paint
- 3. Acceptable Walls: Paint
- 4. Marginal Floor: Laminant - Loose trim

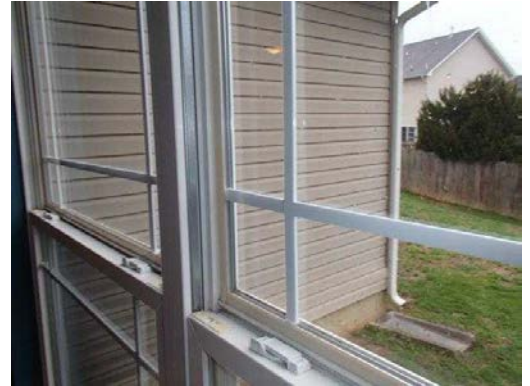
13. Marginal Windows: Good condition - Right rear window not working properly

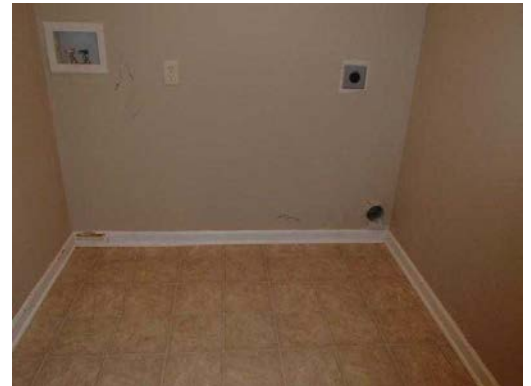
1. View of Laundry room

- 2. Acceptable Ceiling: Paint
- 3. Acceptable Walls: Paint
- 4. Acceptable Floor: Tile
- 5. Marginal Doors: Bi-fold - **Doors need adjustment**
- 6. Acceptable Electrical: 110 VAC
- 7. Acceptable HVAC Source: Present
- 8. Acceptable Washer Hose Bib: Ball valves
- 9. Acceptable Dryer Vent: Rigid metal
- 10. Acceptable Washer Drain: Wall mounted drain
- 11. Acceptable Washer and Dryer Electrical: 110 VAC, 220-240 VAC
- 12. FYI All washer hoses and connections should be inspected for leaks at final walk through and again periodically. Dryer lint traps, ducts and exit covers should also be occasionally inspected and cleaned to guard against lint accumulation that can be a fire hazard.

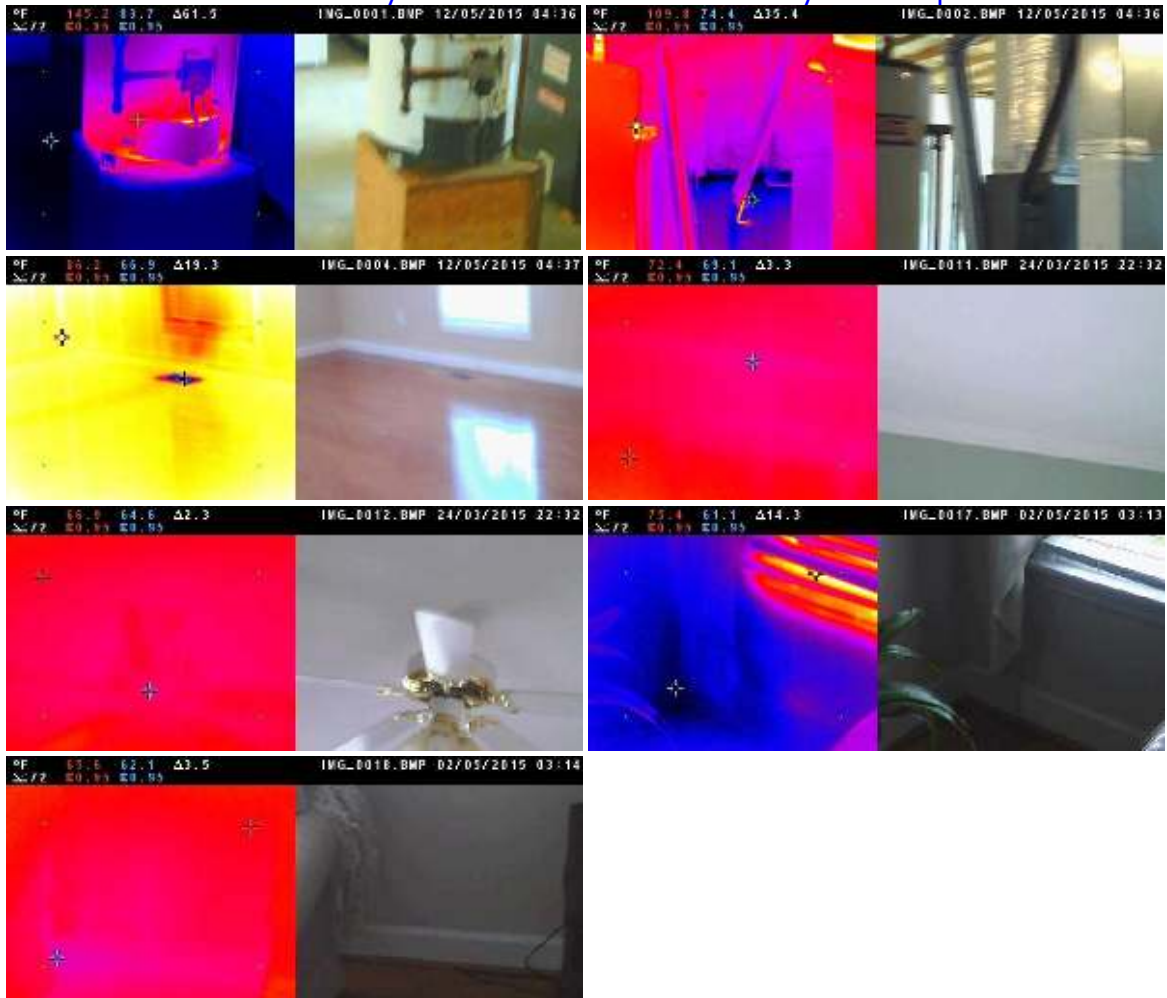
Building Scan No concerns were noted in scan - This is for your information and is not a complete energy scan of the building. This is some pictures we took during the inspection to provided a better home inspection. Infrared cameras can not see through walls but are very effective at documenting consistent temperature which is congruent with dry surfaces. If there were and concerns found they will be documented in the body of the report.

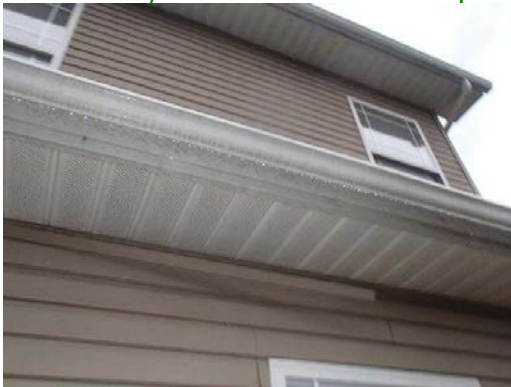
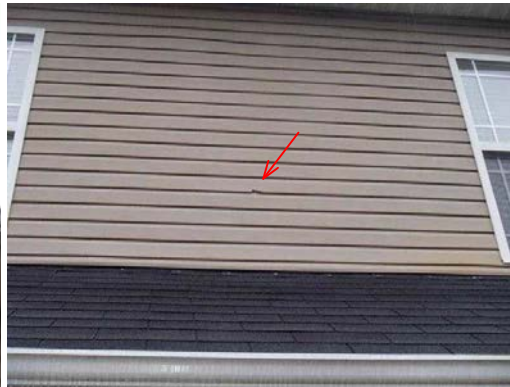
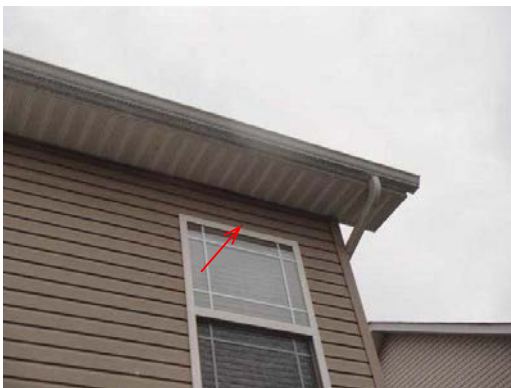
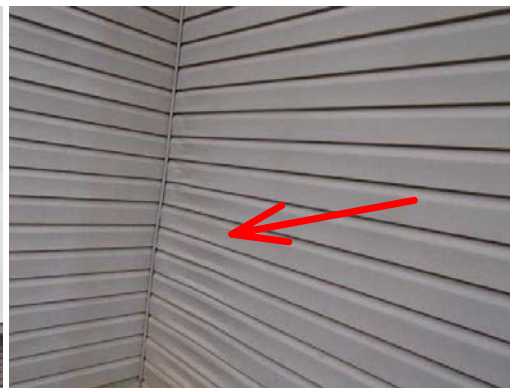
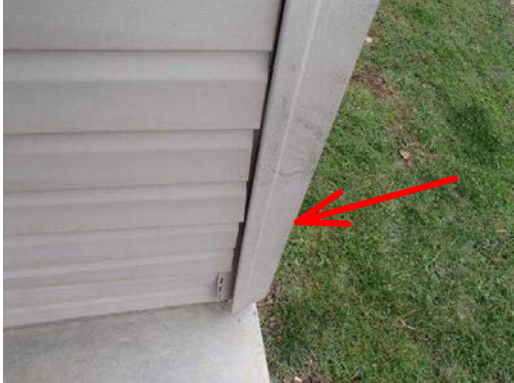
2. Main, Sides and rear Exterior Surface Type: Vinyl siding - **Small holes and cracks in rear, Sagging from heat in rear corner, Loose section at front porch**

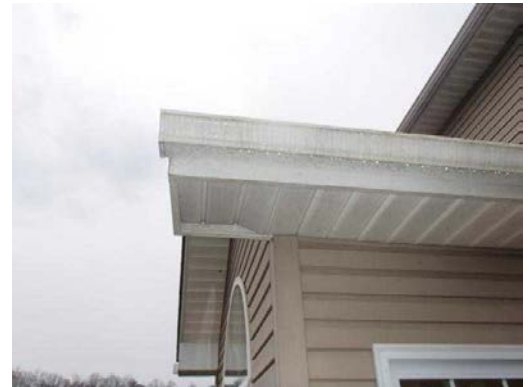
3. Soffits: Vinyl - Small section loose in rear

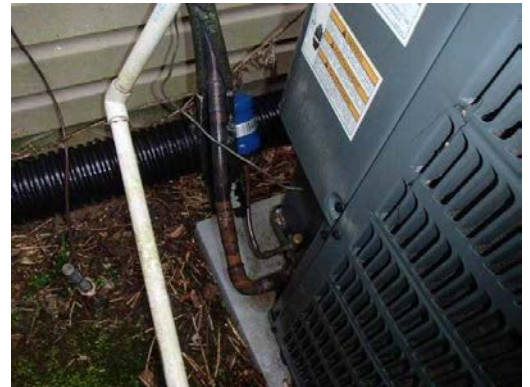
5. Main AC System Refrigerant Lines: Copper - Missing insulation on refrigerant line, Recommend adding insulation to line

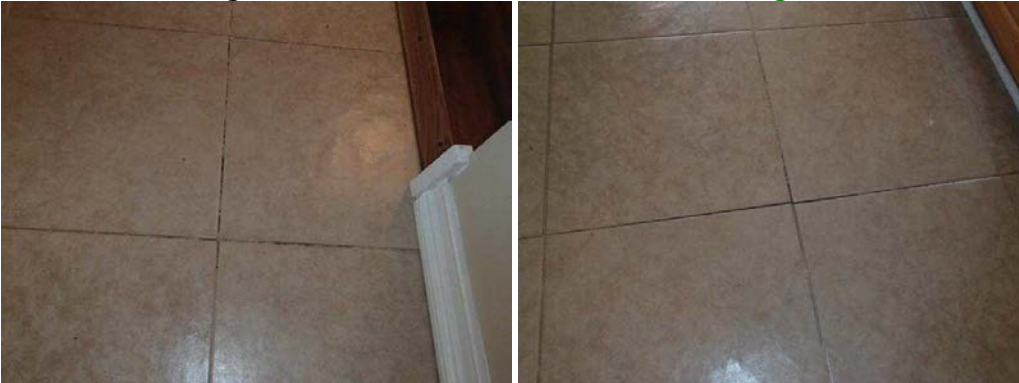
6. Kitchen and dining area Kitchen Floor: Tile - Cracks/ loose grout between tiles

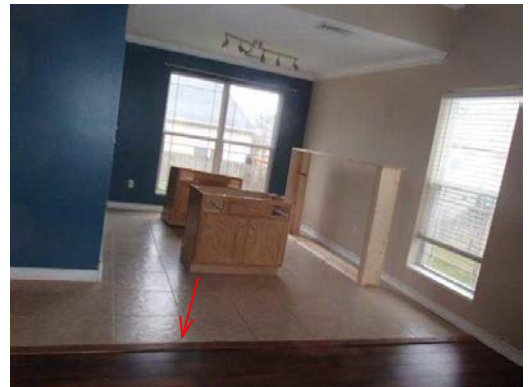
10. Living Room Living Space Floor: Laminant - Loose trim

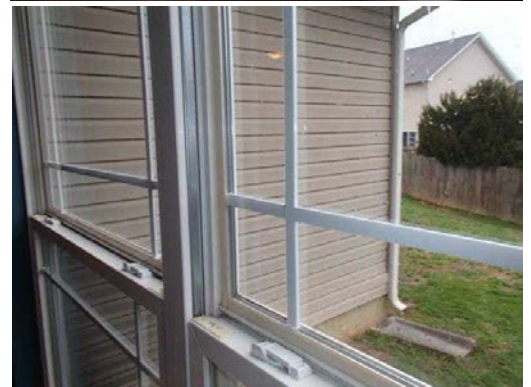
11. Dining Room Living Space Windows: Good condition - Right rear window not working properly

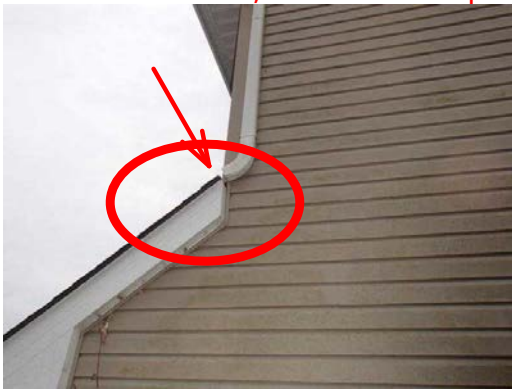
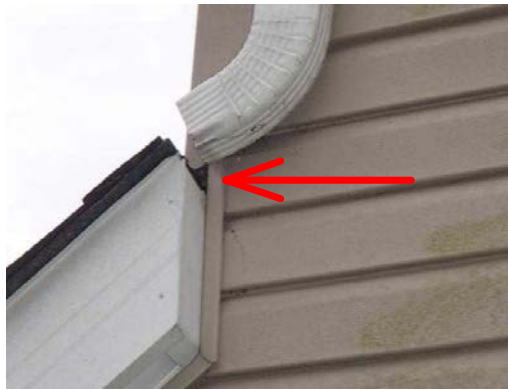
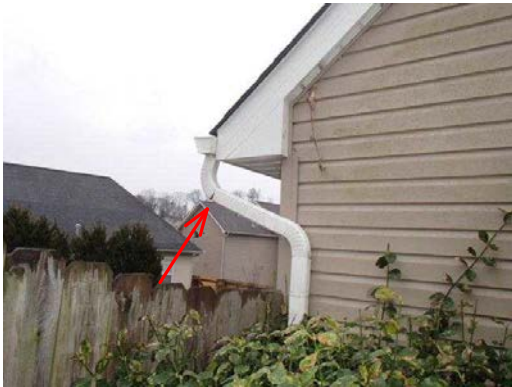
1. Downspouts: Aluminum - Rear left side downspout is turning water into opening above soffit recommend repair and have a contractor evaluate to see if there is water damage inside wall and repair downspout Pulled loose in rear, Recommend repair

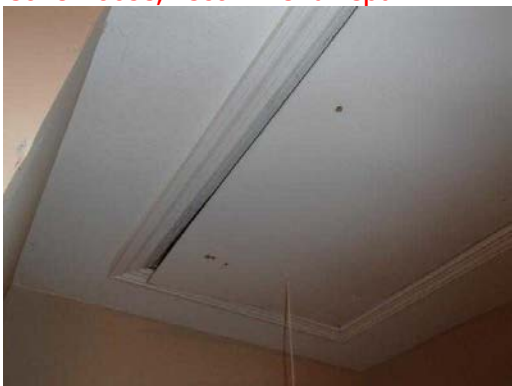
2. Main Attic Access Pull down - Recommend adding nails to hole provided in the metal bracket at top Cover loose, recommend repair

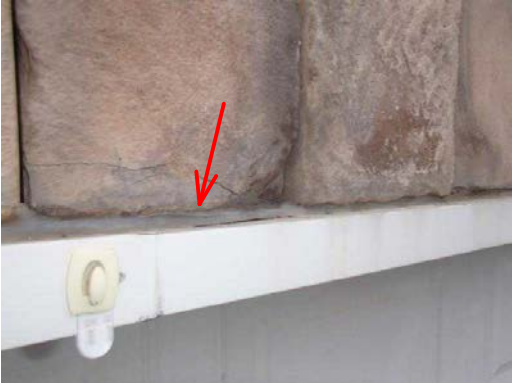
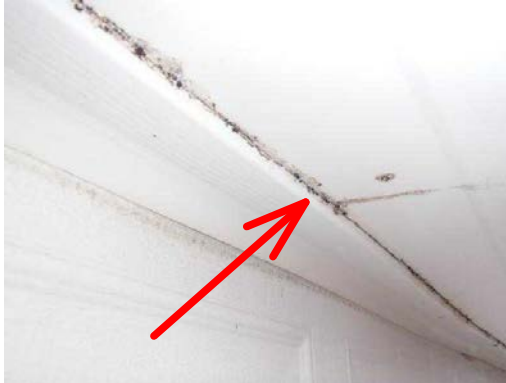
3. Attached Garage Garage door trim Aluminum clad - Evidence of past water intrusion, Caulk added, Soft area on overhead piece of wood trim. Recommend evaluation and repair by a licensed contractor

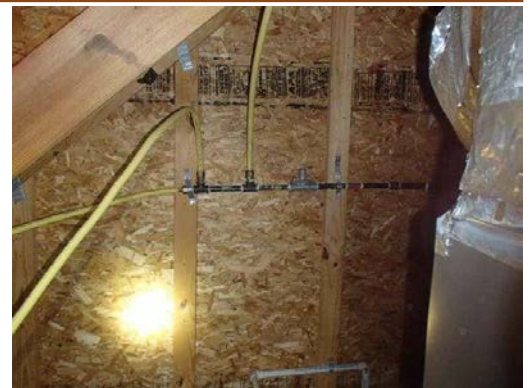
4. Gas Service Lines: Cast iron, CSST - Yellow Corrugated Stainless Steel Tubing (CSST) gas line present and does not appear bonded. Recommend a qualified licensed electrician evaluate and make any necessary repairs. For more information visit www.csstsafety.com

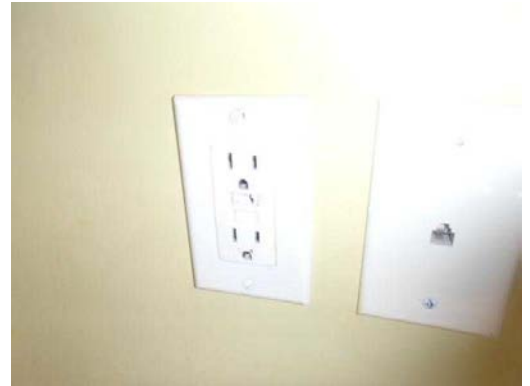
5. Kitchen and dining area Kitchen Electrical: 110 VAC GFCI - **GFCI Outlet on counter is cracked, Recommend replacement**

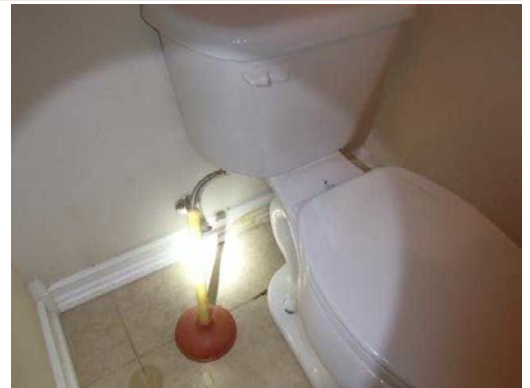
6. 1st floor hall, 1/2 Bath Bathroom Toilets: Adequate - **The toilet is loose at the floor and may require replacement of the wax seal**

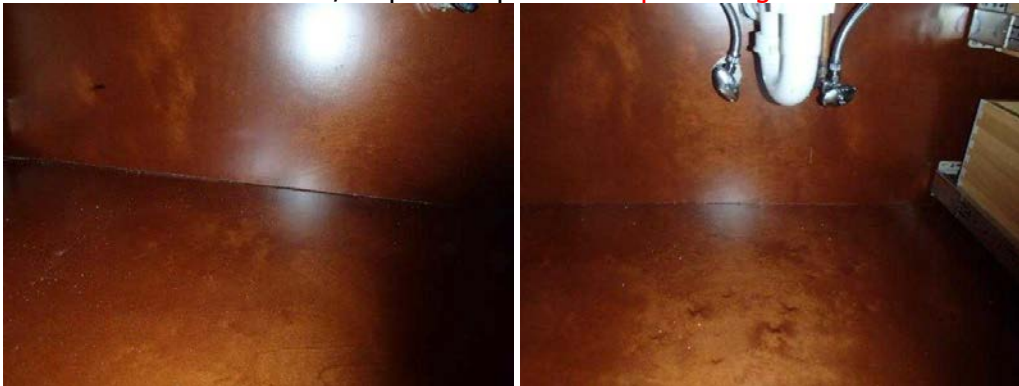
7. Master Bathroom Faucets/Traps: Adequate - **Traps leaking under both sinks**

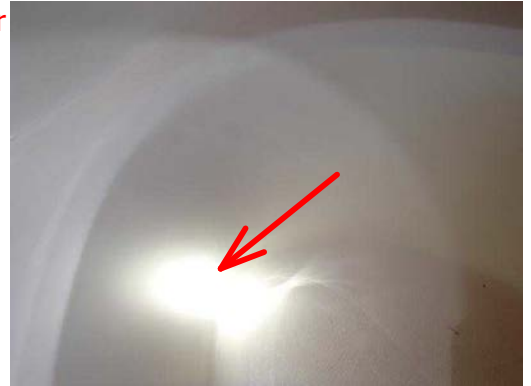
8. Master Bathroom Tub/Surround: Plastic/Fiberglass - Hole with improper repair, Recommend repairs be made by a professional

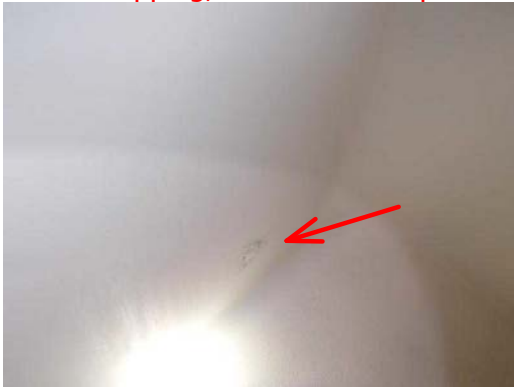
9. Master Bathroom Shower/Surround: Plastic/fiberglass - Hole with improper repair, Recommend repairs be made by a professional
Faucet dripping, Recommend repair

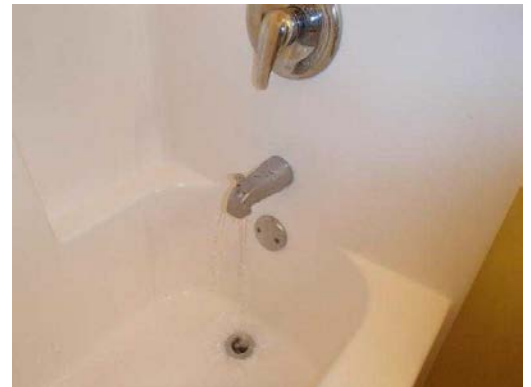
10. Upstairs Bathroom Tub/Surround: Plastic/Fiberglass - Diverter stuck on shower control
