Bentley and Associates, LLC
6683 Poplar Springs Rd
Loudon,, TN 37774
865-986-2516
Donnie Bentley #183

Home Inspection

123 Any Street
Your Town, TN 33333

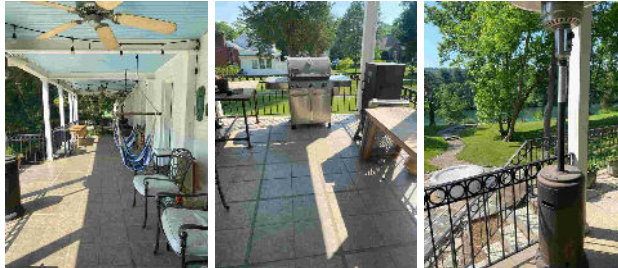
Patio: Paver - Settlement noted, Uneven pavers

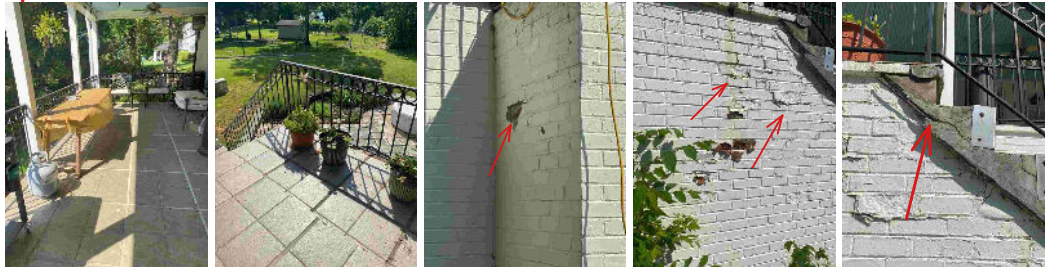
Deck Rails and Steps Metal - Cracked concrete, Spalling brick, A qualified contractor is recommended to evaluate and estimate repairs

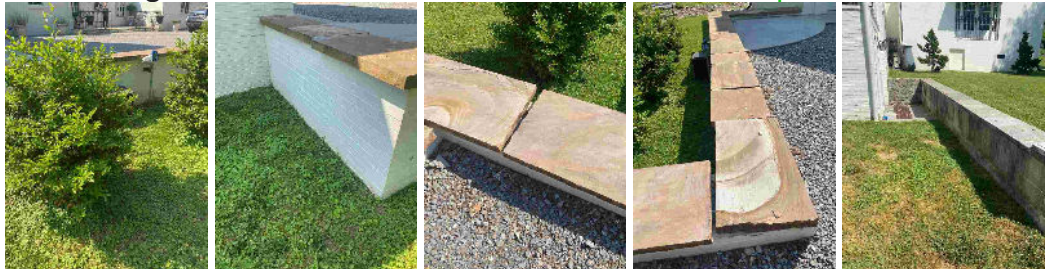
14. Marginal Retaining Walls: Brick, Block, Stone - Loose cap stones

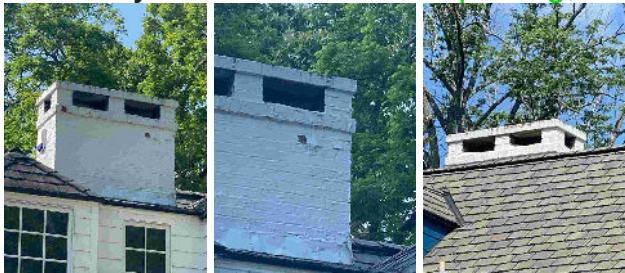
11. Acceptable Chimney: Brick - Surface spalling, Repairs recommended

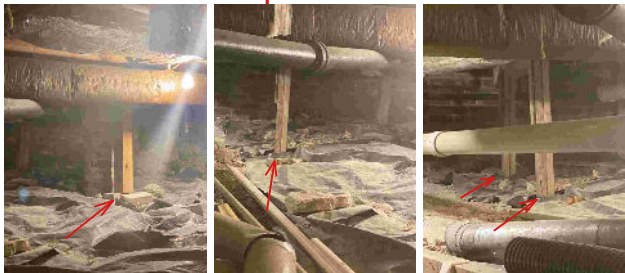
9. Defective Added Piers/Posts: Wood posts - Additional wooden piers have been improperly installed, Wood in contact with soil, Not rated for the load they are supporting, A qualified contractor is recommended to evaluate and estimate repairs

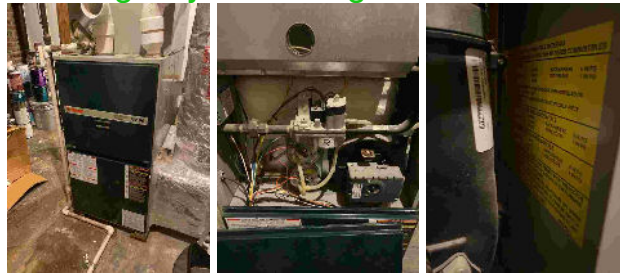
1. Marginal Heating System Operation: Functional at time of inspection - **Furnace existing beyond design life**

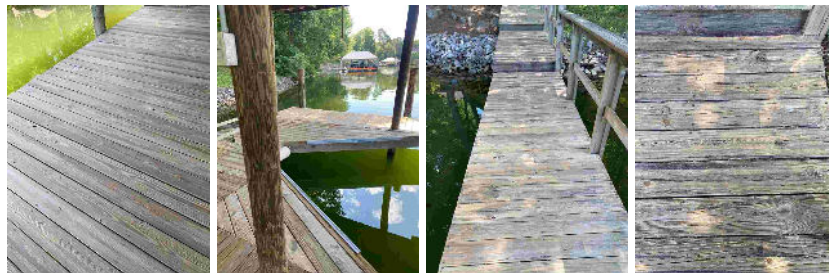
3. Marginal Dock: Treated wood - Weather deck boards noted on most of deck, Some deck boards needs replacement on walkway, A qualified contractor is recommended to evaluate and make necessary repairs

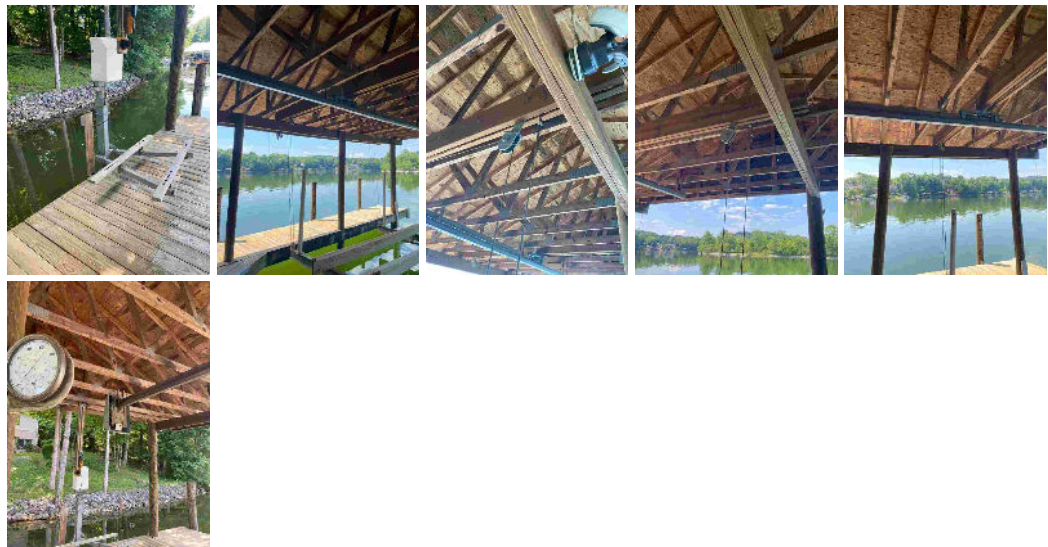
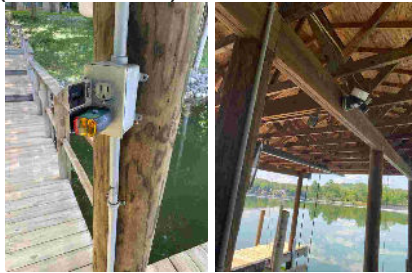
5. Defective Dock Electric 110 VAC - Recommend installing GFCI protected outlets, Lights not working possible blown bulbs daylight sensor present may not be coming on because of sensor

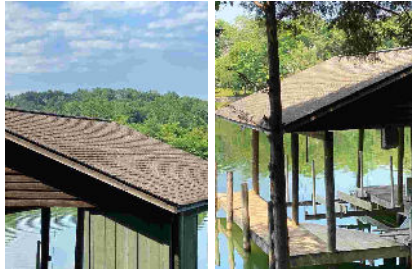
Boat House Roof Asphalt shingle - Visible granular loss noted

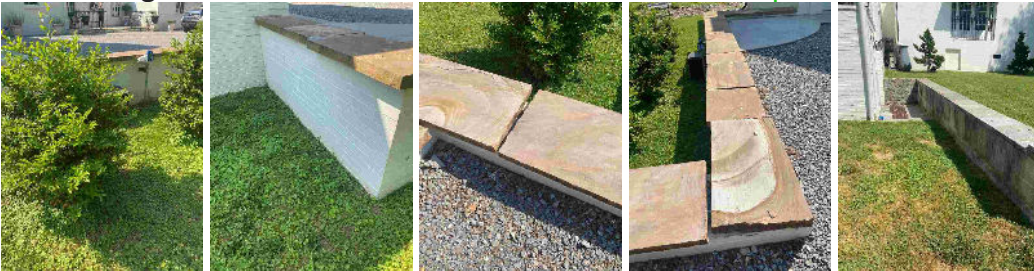
2. Retaining Walls: Brick, Block, Stone - Loose cap stones

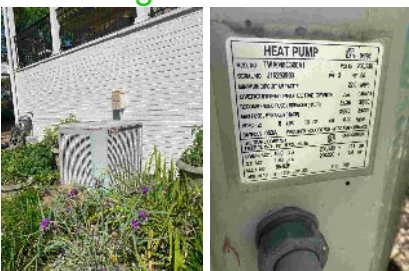
7. Outside AC System A/C System Operation: Functional at time of inspection - The unit is nearing the end of the manufactures stated design life

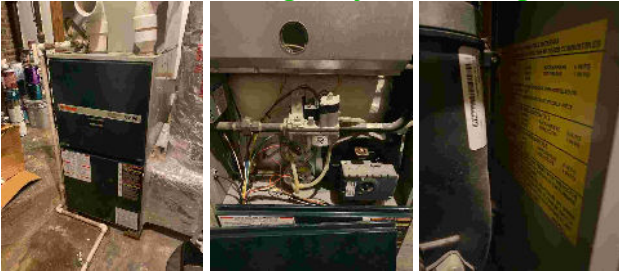
8. Basement Heating System Heating System Operation: Functional at time of inspection
- Furnace existing beyond design life

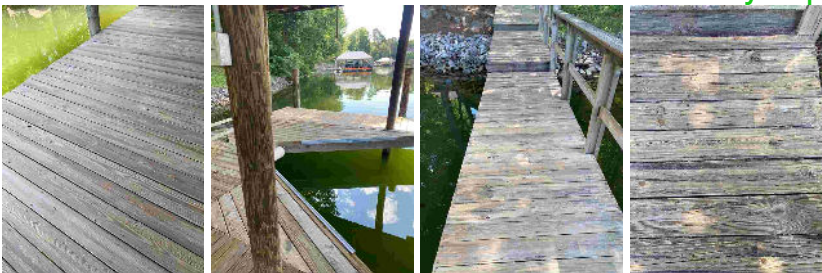
13. Lake Docks/Seawalls Dock: Treated wood - Weather deck boards noted on most of deck, Some deck boards needs replacement on walkway, A qualified contractor is recommended to evaluate and make necessary repairs

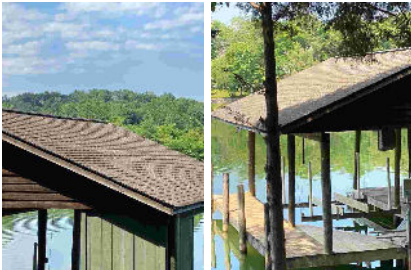
14. Lake Docks/Seawalls Boat House Roof Asphalt shingle - Visible granular loss noted

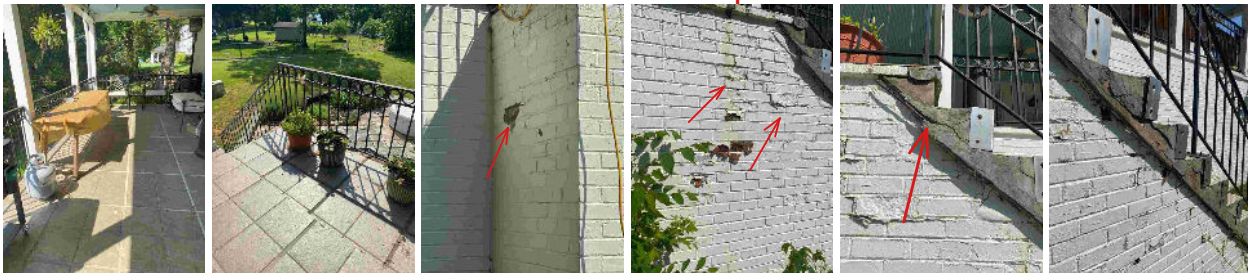
1. Deck Rails and Steps Metal - **Cracked concrete, Spalling brick, A qualified contractor is recommended to evaluate and estimate repairs**

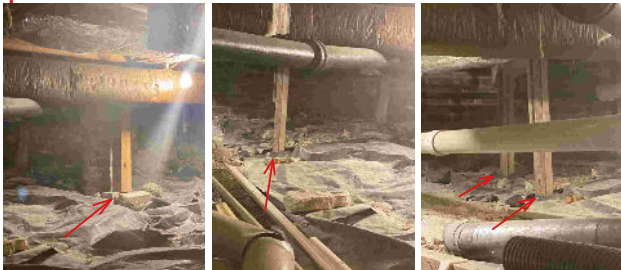
2. Added Piers/Posts: Wood posts - **Additional wooden piers have been improperly installed, Wood in contact with soil, Not rated for the load they are supporting, A qualified contractor is recommended to evaluate and estimate repairs**

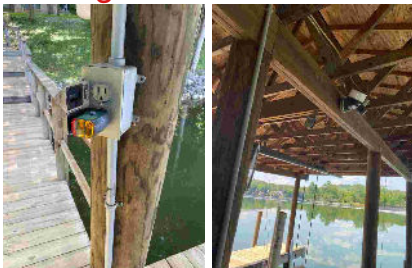
3. Lake Docks/Seawalls Dock Electric 110 VAC - **Recommend installing GFCI protected outlets, Lights not working possible blown bulbs daylight sensor present may not be coming on because of sensor**
